Annual Operation and Maintenance appraisal and its importance

Summary

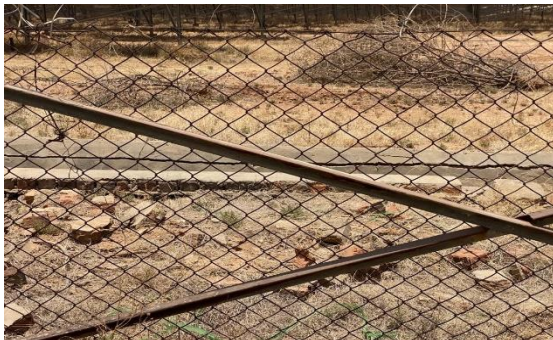
Figure (A)

- The ISMC channel at majority of the location was observed to be partially or completely rusted in in Figure (A). The rusting of the ISMC channel can lead to corrosion in future. SgurrEnergy has suggested to clean the channel with sand paper or wire brush. Further, a coat of red-oxide followed with an anti-rust paint was suggested to be applied on all the affected ISMC channel.
- In Figure (B), significant gap was observed between the natural ground and wire mesh, due to soil erosion. This is envisaged to be infringement points of the plant in the future. These gaps were suggested to be covered with depositing soil underneath the wire mesh to avoid any passage of the inhabitants.

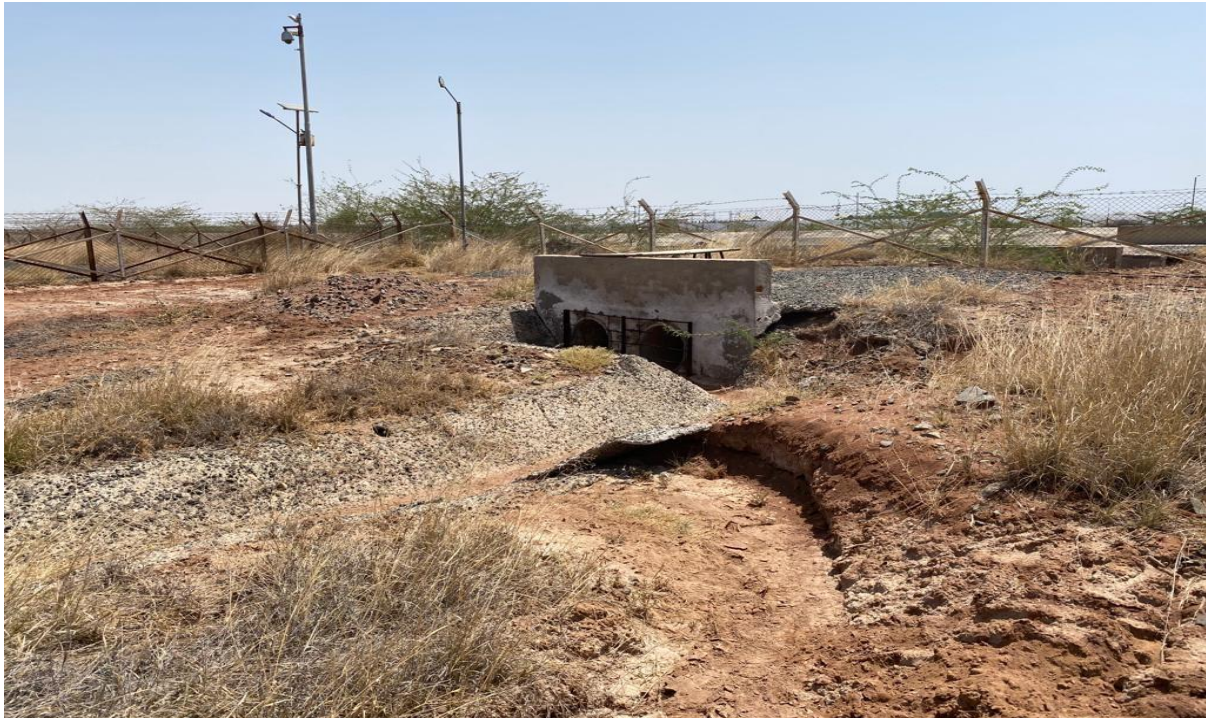
- Figure (C) drainage was observed to be filled with soil or natural vegetation that was blocking the water runoff leading to water accumulation in the PV area which has affected the access to plant thereby increasing the downtime of any maintenance during the monsoon.

- SgurrEnergy could identify that the drainage maintenance was not made a part of regular O&M activity for several years which has resulted in deterioration of the other infrastructure.

- Operator was suggested to survey the existing plant level through DGPS or drone survey, with the input of the site team and local earthen drainage was suggested to be constructed between the rows to channelize and drain off the excess water runoff during the heavy rainfall.

- Further, the drainage filled with soil and natural vegetation was suggested to be cleaned and level of the slope should be maintained after the new drainage survey considering the top level of the drainage at various sections.

- A comprehensive drainage maintenance plan was suggested to be incorporated in the existing maintenance plan to be followed and audited during the annual audits.

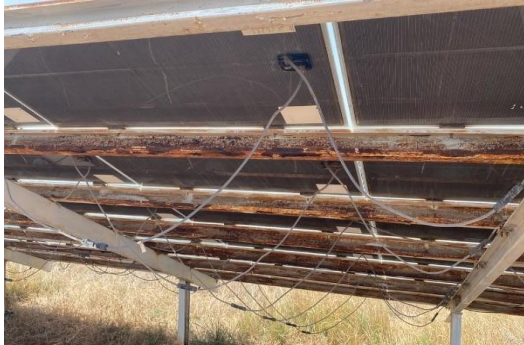
- Figure (D) illustrates that the MMS was not made a part of regular O&M activity which has resulted in significant deterioration of the structure members. The mounted modules gradually got affected due to the corrosion of the structures that had inadvertently affected the stability of the mounted PV modules and had also led to hairline cracks that significantly led to the generation loss of the plant.

- SgurrEnergy has reviewed the structures and has observed that severe corrosion was accelerated due to no maintenance plan being observed for the MMS, further, the gaps between the pile caps and pile foundation were not sealed properly in the initial days of maintenance which has led to ingress of water in between the gaps and have helped in creating fissure on the concrete foundations. Pile integrity tests were suggested for the samples to ascertain the defect category and remedial actions were suggested to be performed for increasing the lifespan of the affected piles.

- Since the MMS were significantly corroded, a detailed plan was drawn out for the replacement of the same and a onetime cost was taken in the annual O&M budget to ensure the plant generation are not affected further, the less affected MMS were subjected to reworks by removing the rust and zinc rich paint was applied on all the affected surface.

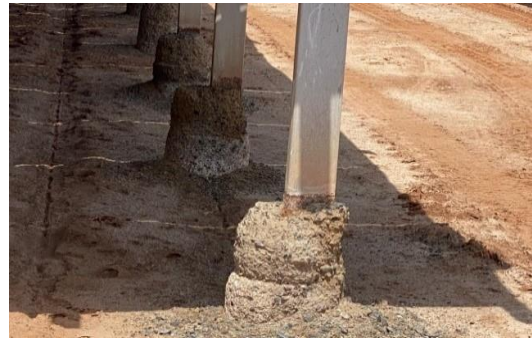
- Figure (E) illustrates, the pile column post was provided with pile caps; however, they were observed to be eccentric in all the Blocks. Further due to significant water run-off and soil erosion around the pile caps, most of the pile caps were observed to be damaged and cavity could be noticed between the pile cap and the pile foundation making it prone to water stagnation that had led to fissures on the pile foundation.

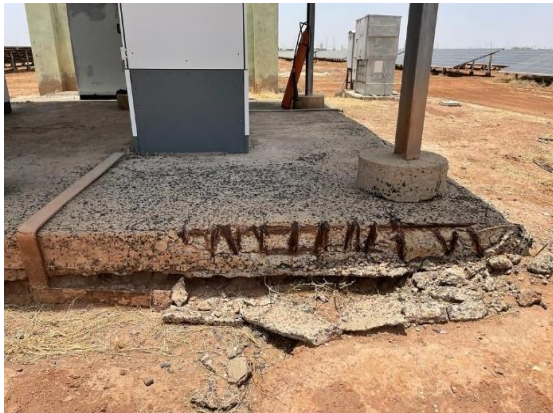
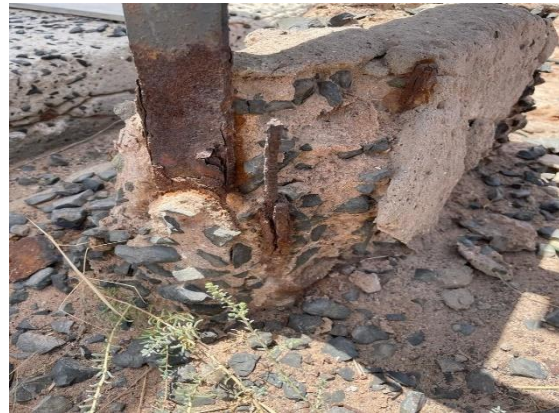
- Figure (F) and Figure (G) illustrates that the grade slab of the inverter station was observed to be deteriorated and reinforcement was found to be exposed and corroded from the sides due to fissures in the grade slab, this had led to decrease in the strength of grade slab. SgurrEnergy suggested to perform the hacking of the exposed area till the reinforcement were found of good quality and the affected reinforcement were suggested to be replaced with the new reinforcement as per the approved drawing and followed by re casting of the grade slab.

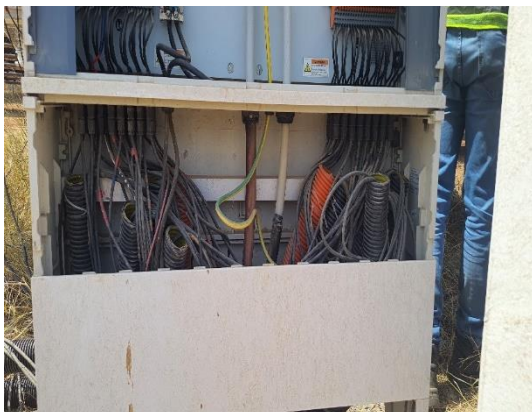
Figure (H)

- String identification ferrules were noted to be missing for the strings in the combiner box. These were leading to added time in the fault clearing during the operation of the plants. Ferrules for string cables were suggested to be provided for ease of identification during performance of maintenance activities and fault troubleshooting.
- DC cables were terminated by providing insulation tape instead of heat shrink sleeves which had led to non-linear heat distribution thereby leading to short circuits. SgurrEnergy suggested to replace all the insulation tape with adequate rated heat

shrink sleeves for DC cables at all such locations for protection of cable and allowing for proper heat dissipation.
